Landsat-6 Failure Investigation Final Report Summary

January 16, 1995

**National Oceanic and Atmospheric Administration (NOAA)
Landsat-6 Failure Review Board**

**Martin Marietta Corporation
Investigation Board**

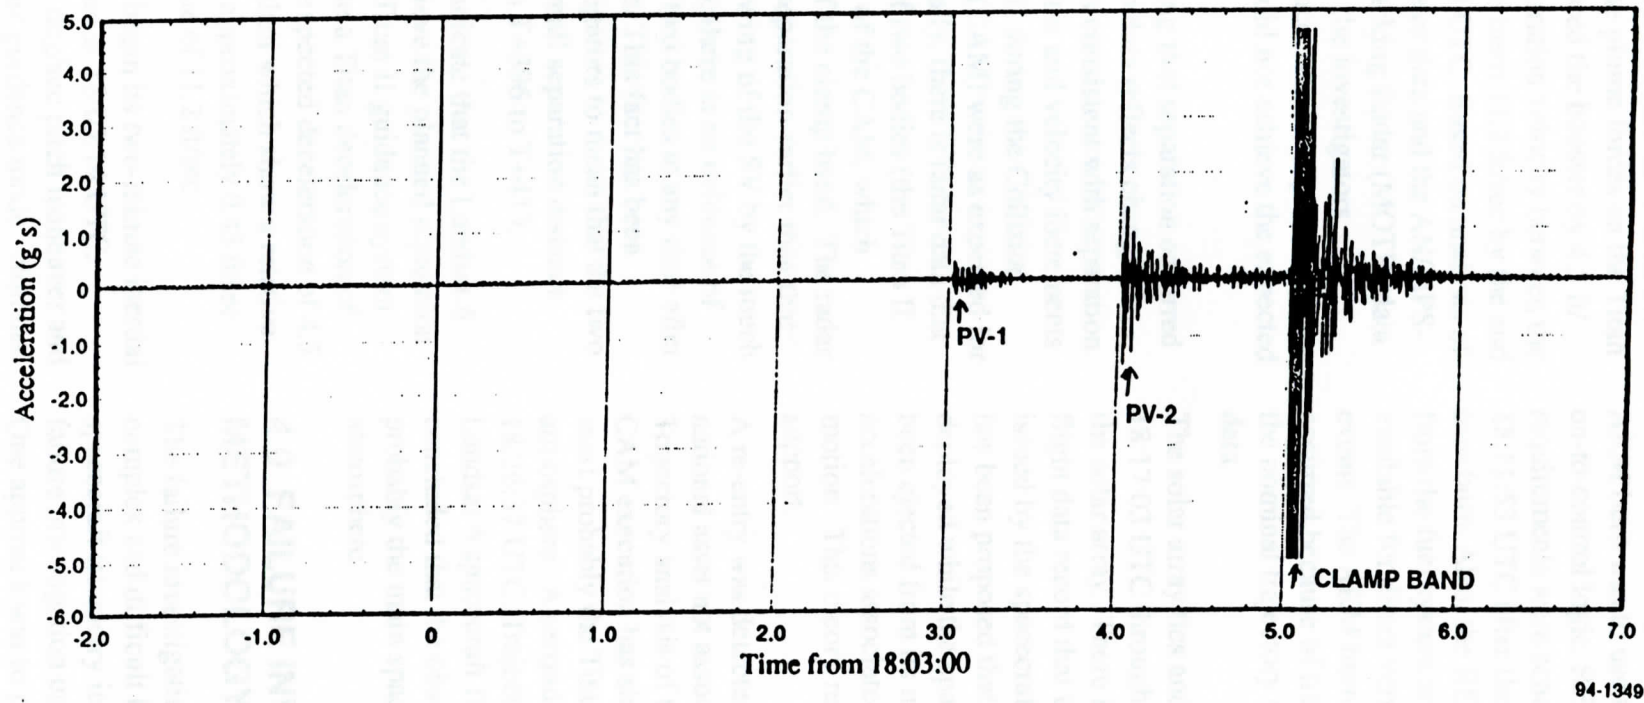
Figure 6. Titan IIG-5 2390: Accel, Tangential, Stage II SV Adapter

At 18:03:03 UTC, the half-second vent program was scheduled to terminate. Simultaneously, the first pyrovalve (PV-1) was to be actuated. Firing PV-1 should have begun filling and pressurizing the REA manifold up to several hundred psia. At 18:03:04, AGS was to actuate the redundant pyrovalve (PV-2). At 18:03:05, the clamp band was scheduled for release. This was the last pyrotechnic event of the separation sequence. All of the Titan II accelerometers recorded three events at precisely the time that AGS was expected to execute the pyrotechnic events. The Investigative Board accepted this data as verification that the AGS was operating properly and that the pyrovalves and clamp band were actuated at the proper time (See Figure 6).

under normal circumstances. The analytical velocity increment imparted to the spacecraft at the conclusion of this burn should have been 6.7 ft/sec. The impact of the plume forces on the Titan II should have decelerated the booster by 4.5 ft/sec. Therefore, the separation velocity between the two bodies should have been 11.2 ft/sec by the end of the burn at 18:03:10 UTC. Based on analysis of the Titan II accelerometer data and the AN/MPS-39 Multiple Object Tracking Radar (MOTR) data for this period of time, the investigators determined that the spacecraft did separate from the booster, but that it did not achieve the expected separation velocity.

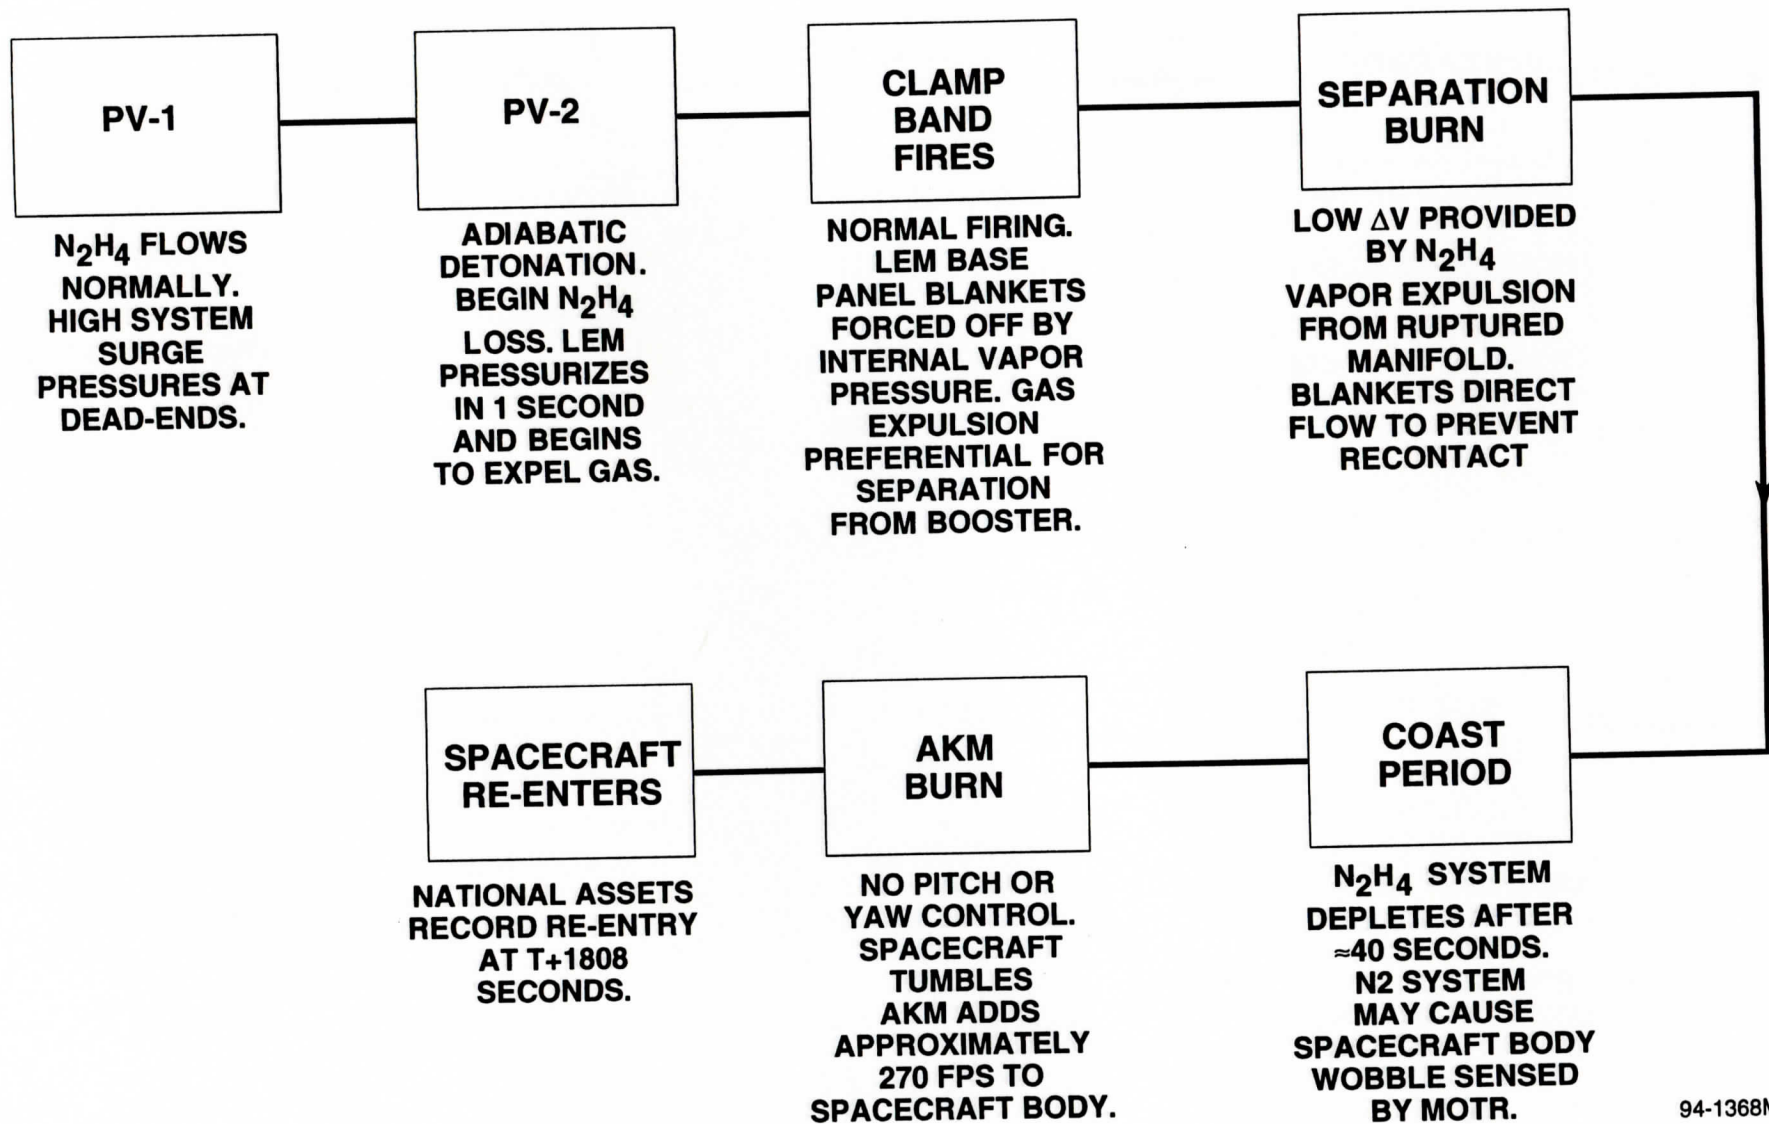
Figure 7. Scenario I, Hydrazine Manifold Ruptured by Adiabatic Detonation

SCENARIO I: HYDRAZINE MANIFOLD RUPTURED BY ADIABATIC DETONATION (FIGURE 7)

Scenario I proposes that PV-1 actuation occurred normally and that system flow and mechanical integrity were maintained until PV-2 was activated. Then, simultaneous with PV-2 actuation, an adiabatic detonation occurred that ruptured the 1/2-inch manifold, near PV-2. There were three root causes postulated for the detonation. First, preliminary analysis predicted high pressure (>3500 psi) at the interface of the two liquid columns as they flowed together in PV-2. Second, it was proposed that the waterhammer shock produced at PX-5 traveled back into the 1/2-inch manifold and added to the shocks produced by actuating PV-2. The third proposed cause was that the first waterhammer event produced an adiabatic detonation at PX-5, and its much larger shock wave added to the shock of actuating PV-2. Both the second and third root causes relied on the shock from PX-5 to increase the local PV-2 pressure above the adiabatic threshold. The scenario goes on to propose that the clamp band firing was normal and that the spacecraft was separated from the booster by the separation connector spring forces assisted by the spring forces at the cooling line interface. The two bodies were kept from recontacting each other by the venting of the hydrazine vapor from the LEM,

Scenario I proposes that the failure was caused by a detonation that occurred simultaneously with the initiation of PV-2, and therefore offers an explanation for the greater shock level recorded at PV-2 initiation. Inasmuch as this postulate doesn't controvert any of the recorded shock data, the scenario and data support each other.

Scenario I is very close to explaining all of the flight data. The difficulty with this scenario is in the hydrodynamic details. During the post-flight hydrazine testing with the RCS model described in Section 5.0, the PX-5 location did not show signs of adiabatic compression induced decomposition, or detonation. There was no tube distension. There was no detonation characteristic pressure buildup, but rather, the peak pressures at that location were the result of the waterhammer effect and nothing more. Pressure data obtained from the water tests are found to be consistent when compared for timing and peak pressure surges. These similarities indicate that identical phenomena were responsible for the pressure spikes at PX-5 regardless of the fluid in use.

The scenario may violate the single mechanism requirement by relying on adiabatic detonation at PX-5 to propagate to another part of the system in order to match the flight accelerometer data. Further, the test data show that the shock wave that leaves the PX-5 location and travels throughout the system is completely dissipated by the time of PV-2 initiation. However, since the Investigative Board cannot precisely determine the exact cause of the rupture, this scenario is considered feasible and probable.

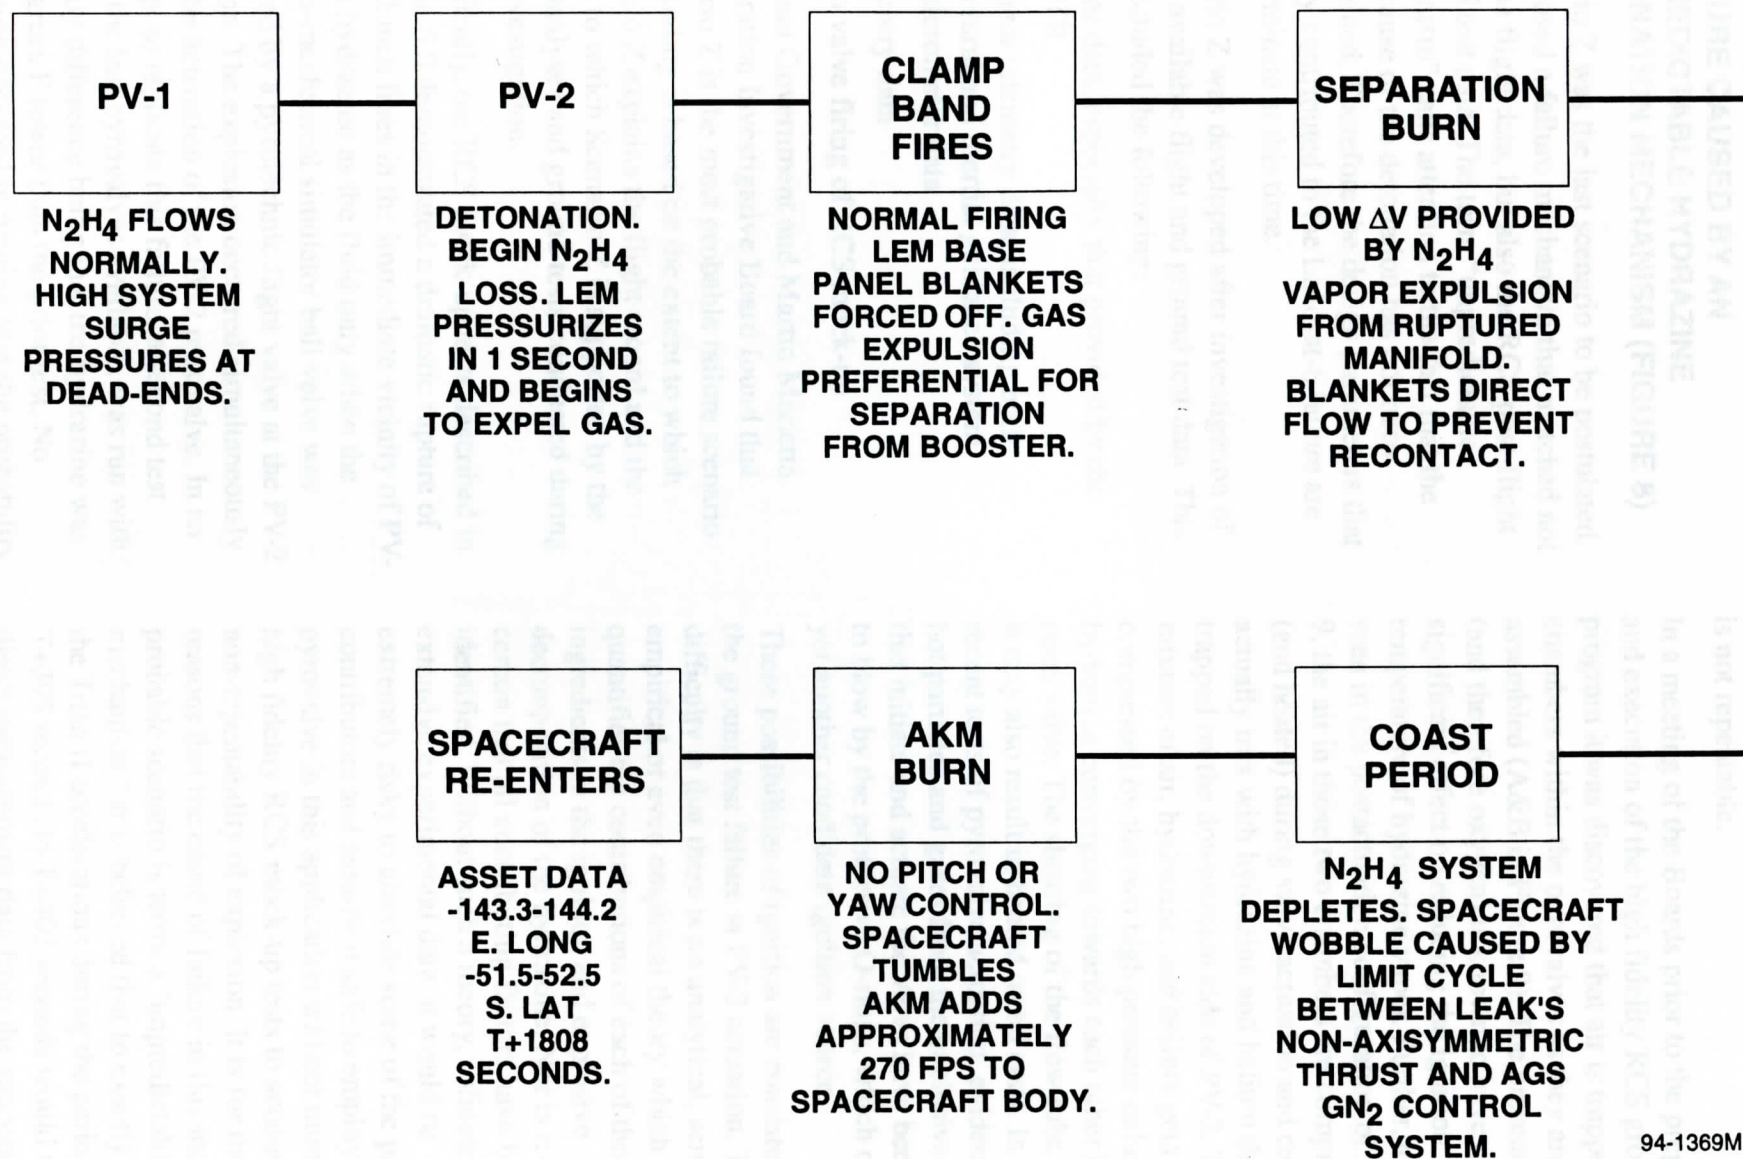
Figure 8. Scenario Z, Hydrazine Manifold Rupture Caused by an Unpredictable Hydrazine Detonation Mechanism

SCENARIO Z: HYDRAZINE MANIFOLD RUPTURE CAUSED BY AN UNPREDICTABLE HYDRAZINE DETONATION MECHANISM (FIGURE 8)

Scenario Z was the last scenario to be postulated. It proposed a failure mechanism that matched not only the flight data, but also the RCS post-flight ground test data. The term "unpredictable mechanism" calls attention to the fact that the exact cause of the detonation has not been determined. Therefore the design parameters that directly contributed to the Landsat-6 failure are indeterminate at this time.

The Joint Government and Martin Marietta Corporation Investigative Board found that Scenario Z is the most probable failure scenario. This finding is based on the extent to which Scenario Z explains the flight record and the extent to which Scenario Z is supported by the RCS analyses and ground tests conducted during this investigation.

Specifically, the RCS mock-up tests described in Section 5.0 demonstrated a dramatic rupture of the 1/2 inch lines in the immediate vicinity of PV-2 with hydrazine as the fluid only when the electro-mechanical simulator ball valve was replaced by a pyrotechnic flight valve at the PV-2 location. The explosion occurred simultaneously with the activation of the PV-2 pyrovalve. In an attempt to replicate this failure, a second test using the last pyrovalves available, was run with the only difference being that the hydrazine was 19 degrees F lower than the prior test. No explosion occurred indicating that the probability

Scenario Z proposes that the failure of the Landsat-6 spacecraft was caused by a hydrazine detonation that occurred at T+395, simultaneous with the initiation of PV-2. The flight data recording showing a much larger shock event at the time of PV-2 firing compared to the shock event recorded for the time of PV-1 firing supports this proposition. The fact that the only detonation encountered during the RCS model testing occurred at the location of PV-2 and simultaneous with its initiation leaves little doubt that this proposition is credible. Additionally, the structural transmissibility test results leave little or no doubt that the signatures of the two pyrovalves should have been nearly identical if both had fired nominally. Finally, the violence of the test detonation, inferred from the test article fragmentation, supports the theory that a detonation would have produced a larger shock signature on the flight accelerometer than a normal pyrovalve firing would produce.

Finally, Scenario Z proposes only one malfunction and explains all the data based on that single failure mechanism. The failure mechanism is supported by the high fidelity RCS mock-up post-flight test data.

A task force should be formed to address the best methodology for determining the parameters that designers must control in order to provide safe and failure-free hydrazine feed systems. The task force should enlist

membership from government, industry technical staff, and academia. One likely sponsor of such a task force could be the AIAA. Once the task force issues its recommendations for the research tasks, a funding profile should be established among the corporations and government agencies that will benefit from the results. All test results should be openly shared within the aerospace community. The goal for completion of the research should be no later than December 1995, and a designers handbook should be issued no later than June 1996.
